PLANT AUDIT REPORT

PLANT AUDIT PERFORMED FOR:			
PLACE:			
CONTACT:			
DATE OF AUDIT:		5/8/2011	David Hewitson
TYPE OF MATERIAL PROCESSED:		Blue Metal	ESTIMATED ANNUAL TONNAGES: 900,000 TPA

Please see the attached findings from the site visit performed on **Date 5/8/2011**

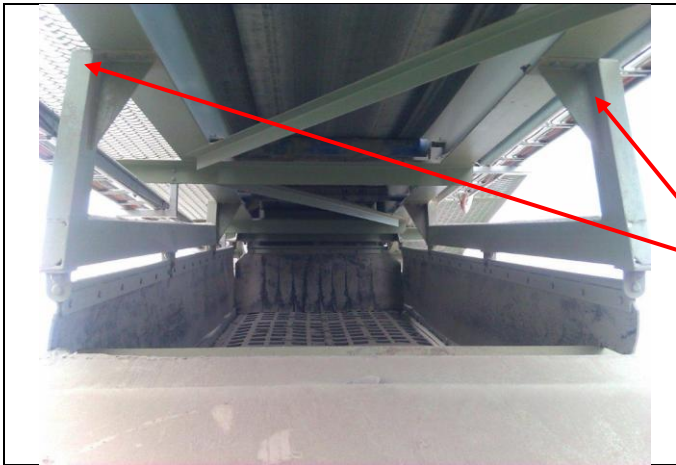
#1

Observation: Material bouncing over the end of the screen
This condition is typical of rubber screen cloths that are under tensioned or where there is insufficient feed.

Solution: Given that the cloth tension is adequate the problem is most likely insufficient feed and bed depth. If the feed rate cannot be increased hang a rubber curtain from the conveyor frame at the end of the screen to prevent spillage.

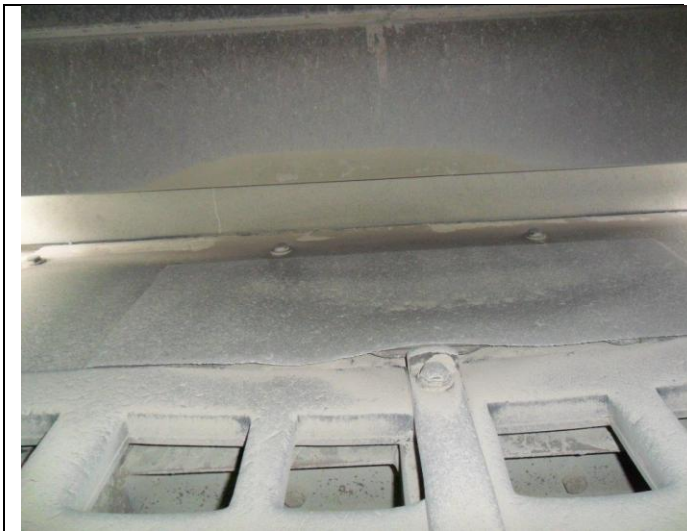
#2

Observation: Worn screen impact plate

Solution: Replace steel plate with 40mm thick steel backed bolt on rubber wear liner for long maintenance free wear life and noise reduction

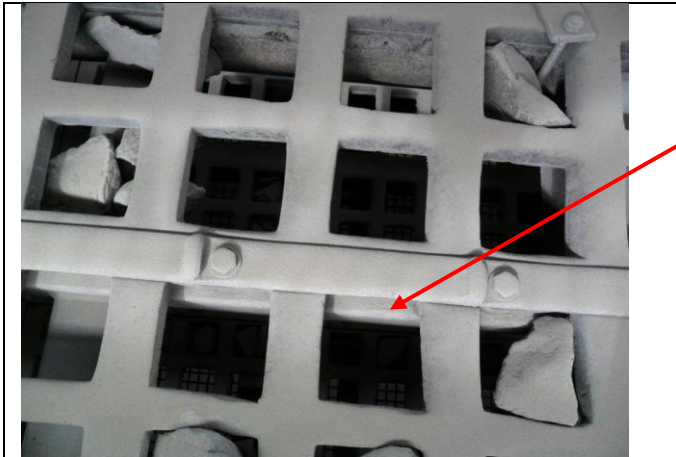
#3

Observation: Screen sub-frame exposed to wear because the rubber screen cloth does not fit correctly. The screen cloth is made to fit a screen deck with 50mm wide centre support.

Solution: Ensure all future supplies of screen cloths are designed to fit your screen with 75mm wide centre support.

Replace steel centre hold down bars with 75mm wide x 50mm thick rubber centre hold down bars

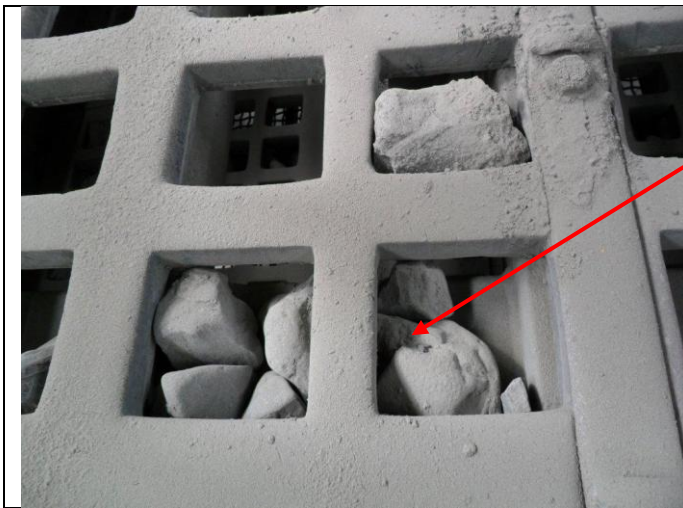
#4

Observation: Material is being trapped between the screen cloth and the screen frame cross beams. The continuous impact and abrasion is causing damage to the frame.

Solution: Blank off the screen cloth over the beams or reduce the size of the apertures so the material is small enough to not foul between the cloth and the frame

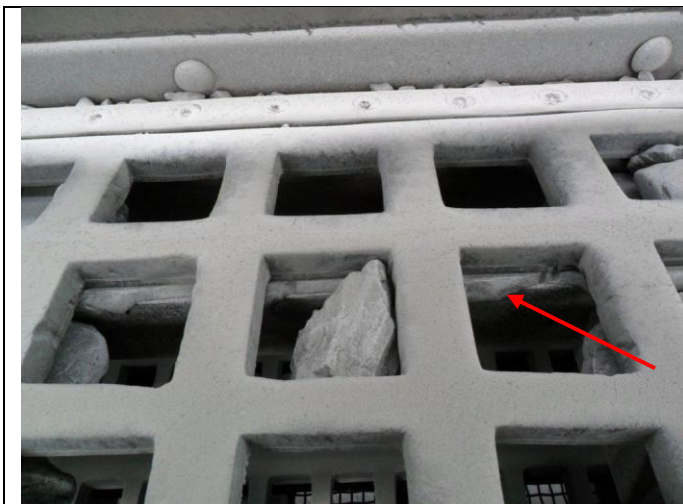
#5

Observation: Rubber screen cloth not fitted correctly. It can be seen that the material has worn through the capping rubber and is damaging the steel support bar

Solution: Always centralise the rubber screen on the screen deck prior to tensioning and use correct tensioning procedures.

Ensure the rubber screen cloth is manufactured to the correct dimension

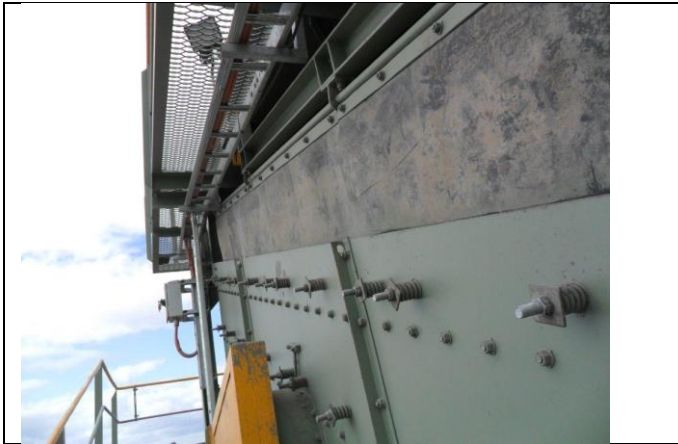
#6

Observation: Tensioning springs used on side clamp bar bolts. Springs can make it very difficult to achieve and maintain even tension on the screen cloth

Solution: Remove springs and replace with domed washer

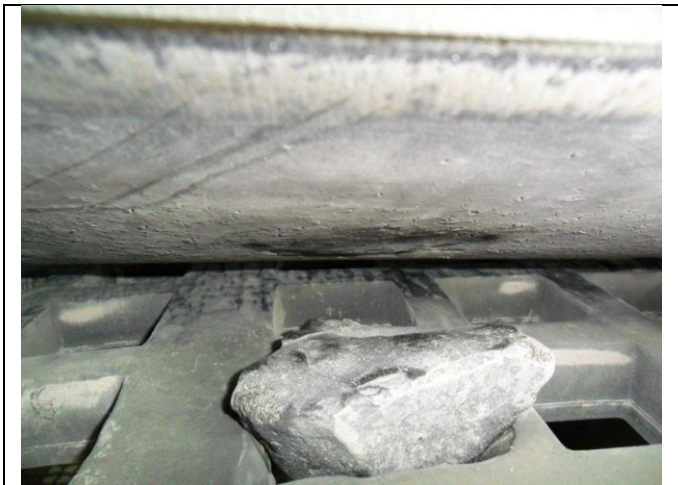
#7

Observation: Material is being trapped between the rubber access point curtain on the feed end of middle deck, causing localised high wear points and reduced screening efficiency

Solution: Cut the rubber curtain shorter so it prevents spillage but does not interfere with screening

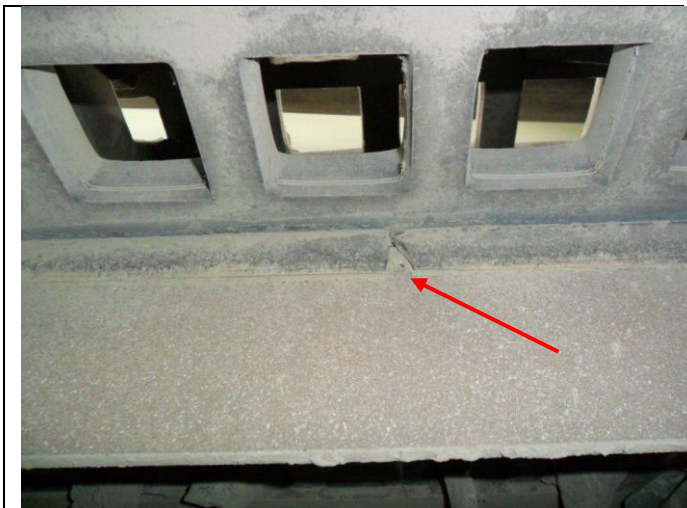
#8

Observation: Hawk screen middle deck- Join in capping rubber

Solution: It is good practice to use one single continuous strip of capping rubber for the full length of the screen

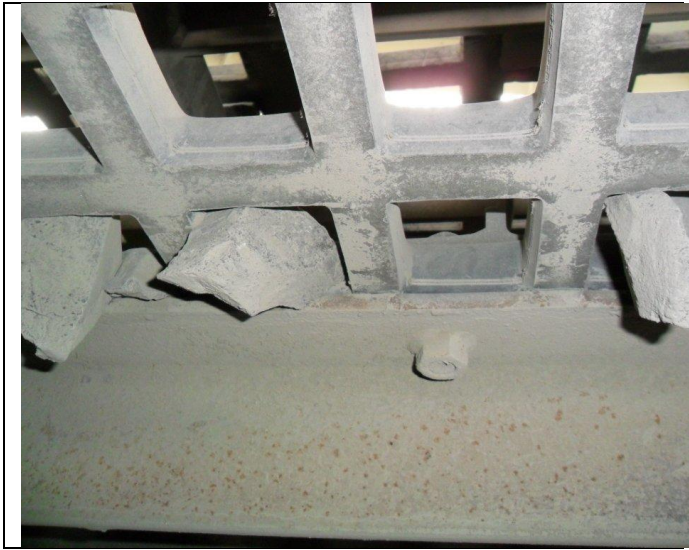
#9

Observation: Hawk screen middle deck- incorrectly fitting screen cloth. Rubber screen cloth not covering the centre support rail. Material pegging and wearing on the frame.

Solution: Always centralise the rubber screen on the screen deck prior to tensioning and use correct tensioning procedures.

Ensure the rubber screen cloth is manufactured to the correct dimension

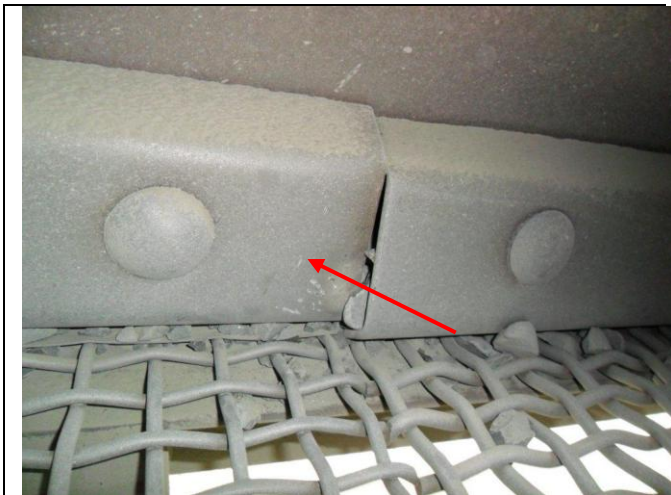
#10

Observation: Hawk Screen bottom deck - Screen cloth side hook hard up against the side wall of screen

Solution: Always centralise the screen on the screen deck prior to tensioning and use correct tensioning procedures.

There should be 15mm – 20mm clearance between the outside edge of the side hook and screen box wall when the screen cloth is correctly tensioned

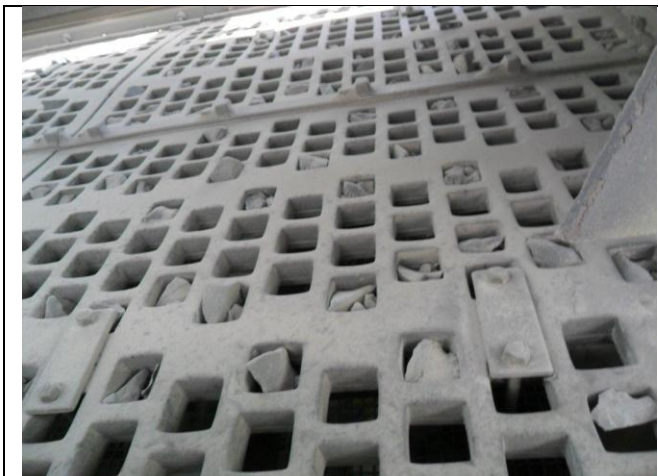
#11

Observation: Screen 3 top deck - Excessive aperture pegging. This can be the result of over tensioned rubber screens or the rubber screen is too thick.

J-bolts used to clamp screens to support rail.

Solution: Reducing the thickness of the rubber screen will reduce pegging, reduce cost, increase screening efficiency and will most likely have no affect on wear life.

J-bolts should not be required on this machine. If there is difficulty in maintaining tension check screen camber and capping rubber profile.

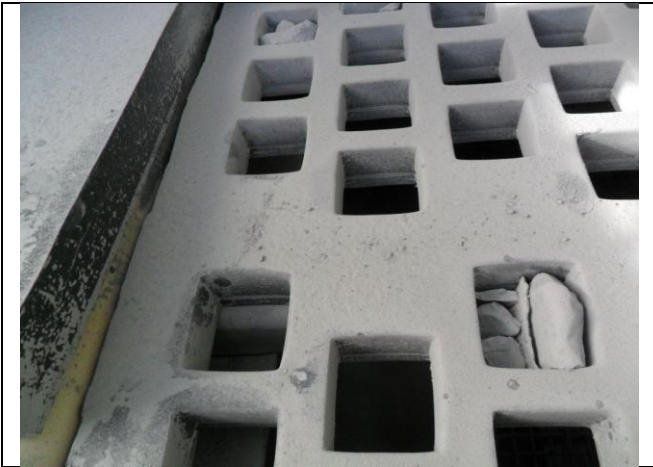
#12

Observation: Screen 3 top deck - Rubber screen cloth not fitted correctly.

Solution: Always centralise the rubber screen cloth on the screen deck prior to tensioning and use correct tensioning procedures.

Ensure the rubber screen cloth is manufactured to the correct dimension

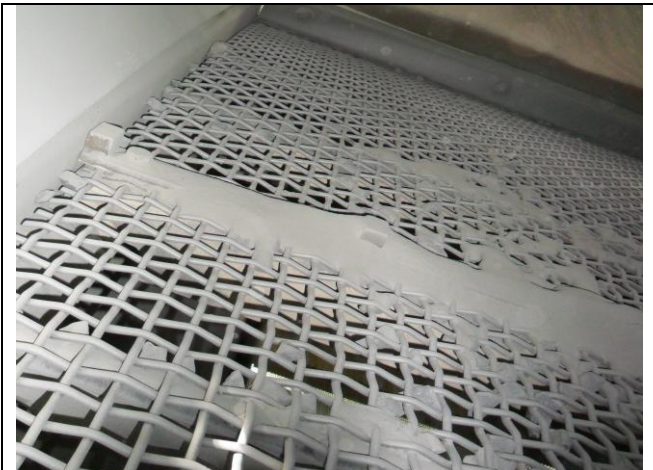
#13

Observation: Screen 3 middle deck – some blinding of woven mesh screens

Solution: If blinding affects screening efficiency consider self cleaning Flexmats or rubber screens

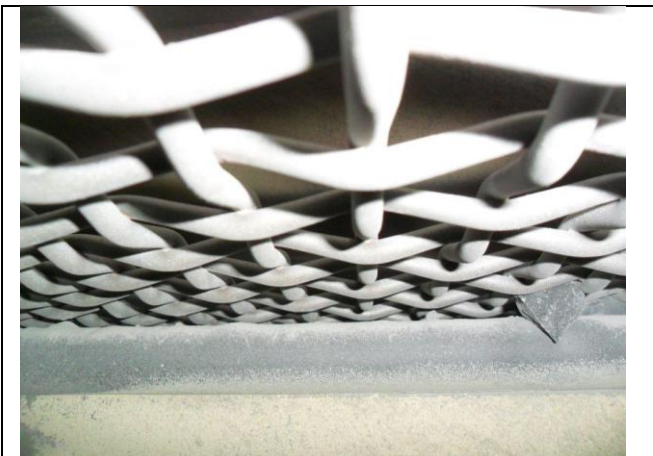
#14

Observation: Middle deck S3 – Screen cloth not sitting on outer support rails. This can have a very serious affect on screen cloth wear life

Solution: Check the screen has been manufactured with the correct crown (camber). This can be done by running a string line over the crown or measure crown against manufacturers specification.

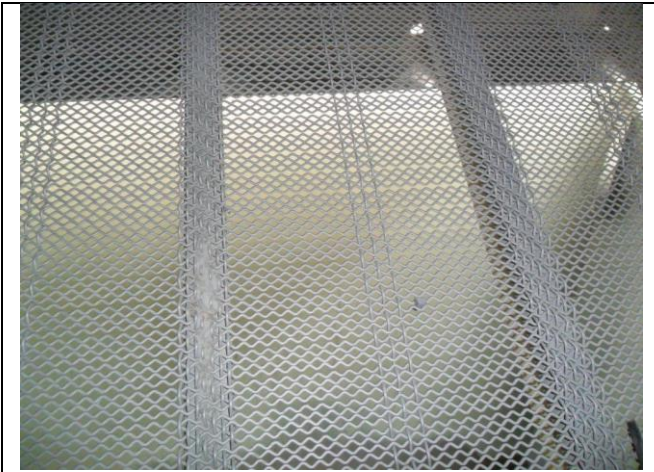
#15

Observation: Inferior quality screen media.

It can be seen that the apertures are quite irregular which will allow oversize material to pass through the screen.

Solution: Replace with high performance Flexmat screens for accurate sizing and longer wear life

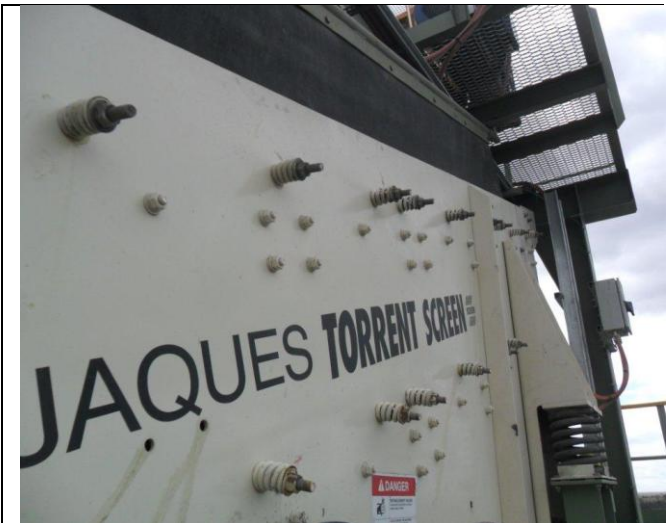
#16

Observation: Tensioning springs used on side clamp bar bolts.

Springs can make it very difficult to achieve and maintain even tension on the screen cloth

Solution: Remove springs and replace with curved washer

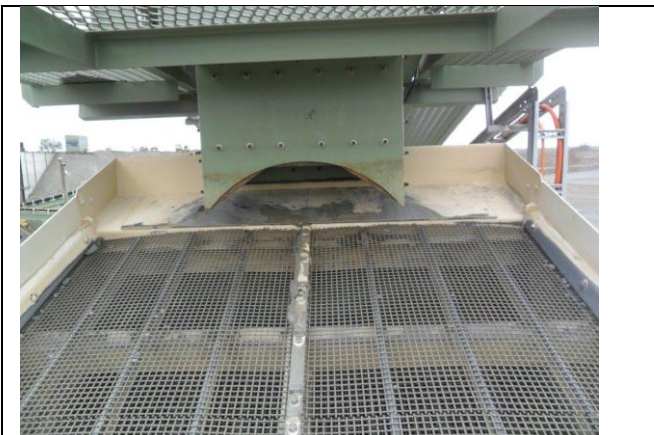
#17

Observation: Screen 4

Steel screen impact plate.

Screen cloth in position 1 - high wear

Solution: When worn replace steel plate with 40mm thick steel backed bolt on rubber wear liner for long maintenance free wear life and noise reduction.

For long maintenance free operation install rubber screen cloth in position # 1

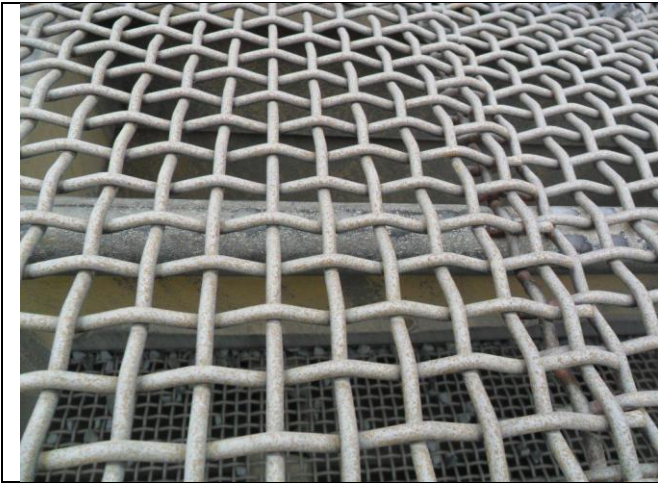
#18

Observation: Top deck S4 – Screen cloth not sitting on outer support rails. This can have a very serious affect on screen cloth wear life

Solution: Check the screen has been manufactured with the correct crown (camber). This can be done by running a string line over the crown or measure crown against manufacturers specification.

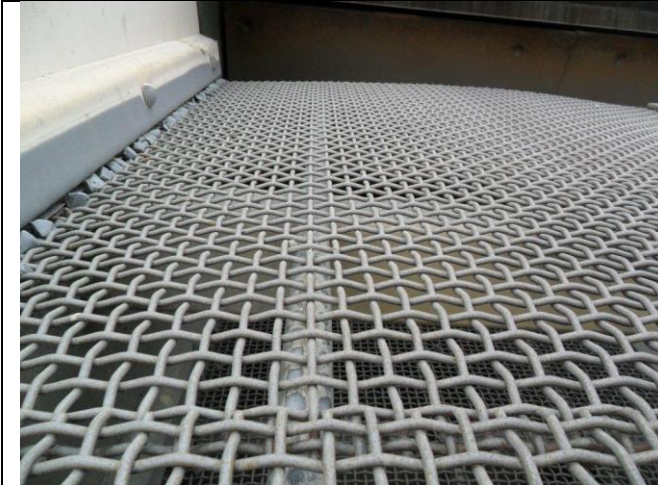
#19

Observation: Top deck S4 - Screen cloth not fitted square

Solution: Always centralise the screen cloth on the screen deck prior to tensioning and use correct tensioning procedures.

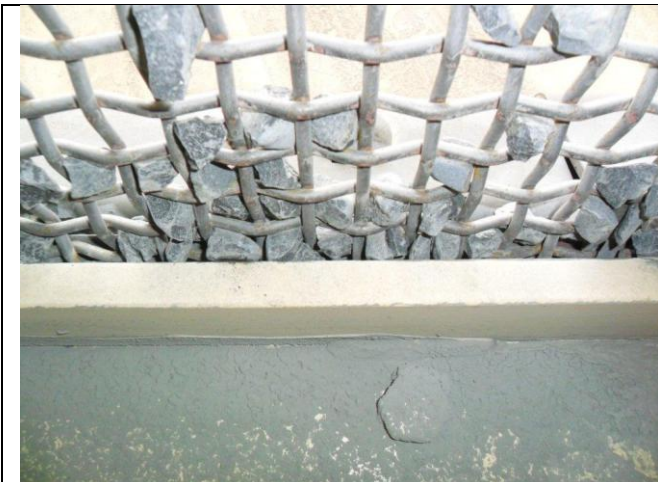
#20

Observation: Top deck S4 – Screen cloth not sitting on side support rails. This can have a very serious affect on screen cloth wear life

Solution: Check the screen has been manufactured with the correct crown (camber). This can be done by running a string line over the crown or measure crown against manufacturers specification

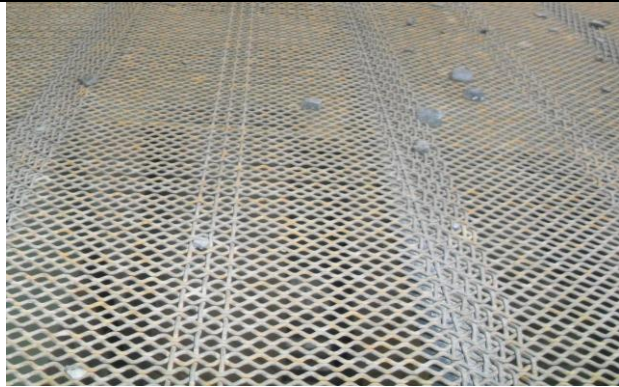
#21

**Observation:** Inferior quality screen media.

It can be seen that the apertures are quite irregular which will allow oversize material to pass through the screen.

Solution: Replace with high performance Flexmat screens for accurate sizing and longer wear life

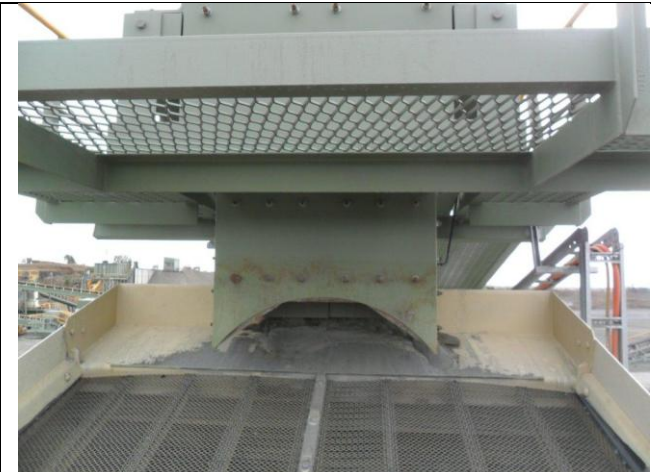
#22

**Observation:** Screen 5

Steel screen impact plate.

Screen cloth in position 1 - high wear

Solution: When worn replace steel plate with 40mm thick steel backed bolt on rubber wear liner for long maintenance free wear life and noise reduction.

For log maintenance free operation install rubber screen cloth in position # 1

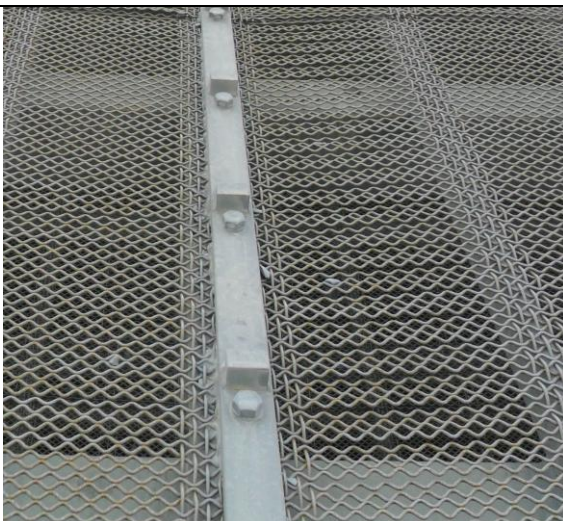
#23

**Observation:** Screen 5 Top deck - Inferior quality screen media.

It can be seen that the apertures are quite irregular which will allow oversize material to pass through the screen.

Solution: Replace with high performance Flexmat screens for accurate sizing and longer wear life

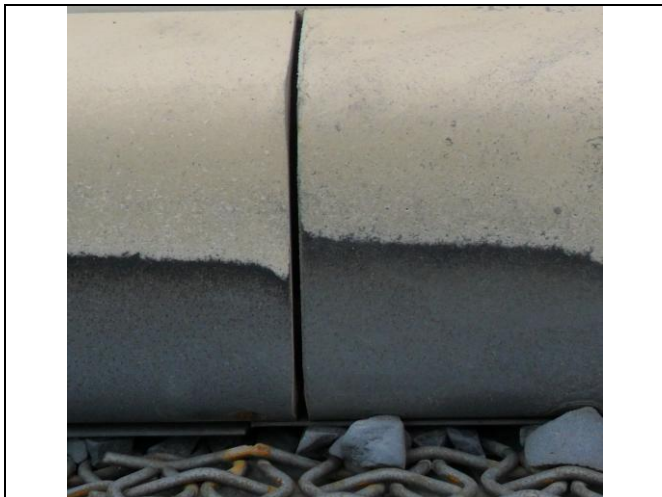
#24

Observation: Screen 5 Top deck – Side clamp overlapping to next cloth making it impossible for accurate tensioning.

It is vital for maximum screening efficiency and screen cloth wear life to maintain good tension

Solution: Never overlap side clamp.

One hook – one side clamp

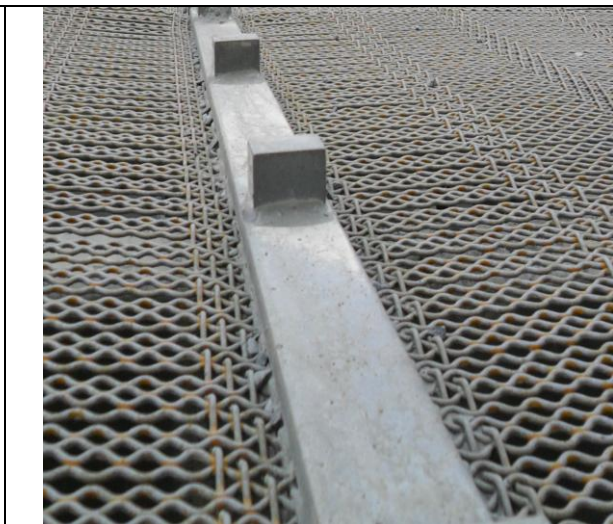
#25

Observation: Screen 5 middle deck - Inferior quality screen media.

It can be seen that the apertures are quite irregular which will allow oversize material to pass through the screen.

Solution: Replace with high performance Flexmat screens for accurate sizing and longer wear life

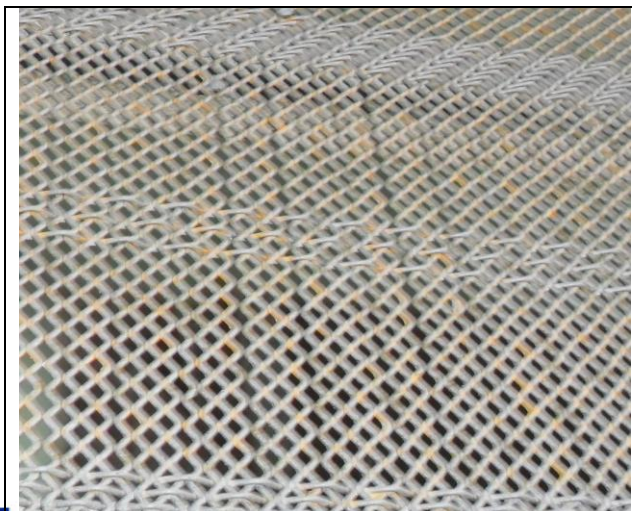
#26

Observation: Screen 5 bottom deck - Inferior quality screen media.

It can be seen that the apertures are quite irregular which will allow oversize material to pass through the screen.

Solution: Replace with high performance Flexmat screens for accurate sizing and longer wear life

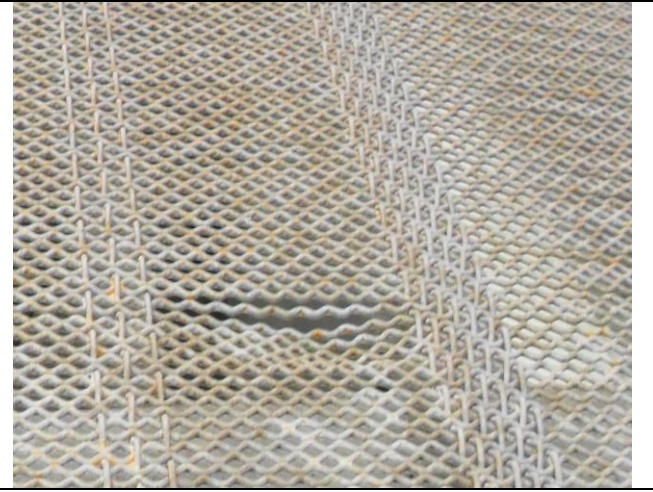
#27

**Observation:** Screen 5 bottom deck – damaged cloth**Solution:** Replace

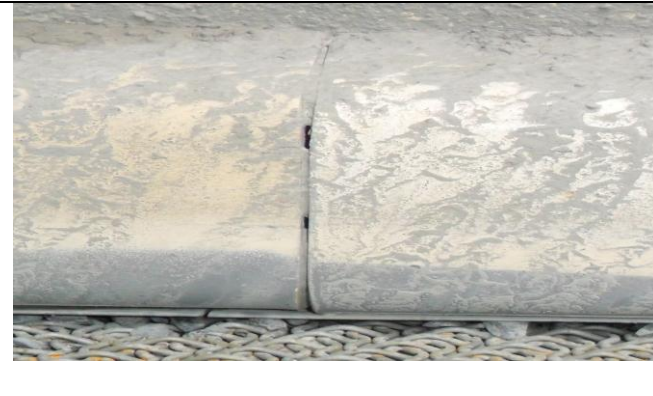
#28

**Observation:** Screen 5 bottom deck – Side clamp overlapping to next cloth making it impossible for accurate tensioning.

It is vital for maximum screening efficiency and screen cloth wear life to maintain good tension

Solution: Never overlap side clamp.**One hook – one side clamp**
