PLANT AUDIT REPORT

PLANT AUDIT PERFORMED FOR:			
PLACE:			
CONTACT:			
DATE OF AUDIT:		5/8/2011	David Hewitson
TYPE OF MATERIAL PROCESSED:		Blue Metal	ESTIMATED ANNUAL TONNAGES: 900,000 TPA

Please see the attached findings from the site visit performed on **Date 5/8/2011**

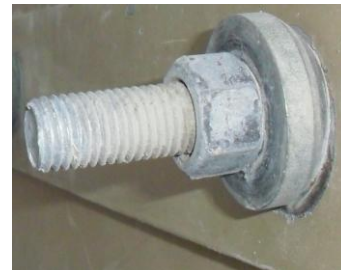
Springs can make it very difficult to achieve and maintain even tension on the screen cloth

Solution: Remove springs and replace with curved washer
